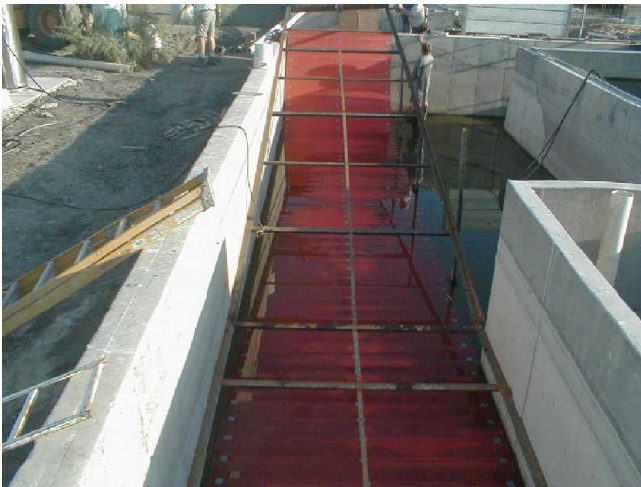
Photograph 13. A steel framework was constructed to support the Algal Sedimentation Belt installed under the Primary Fish Zone.

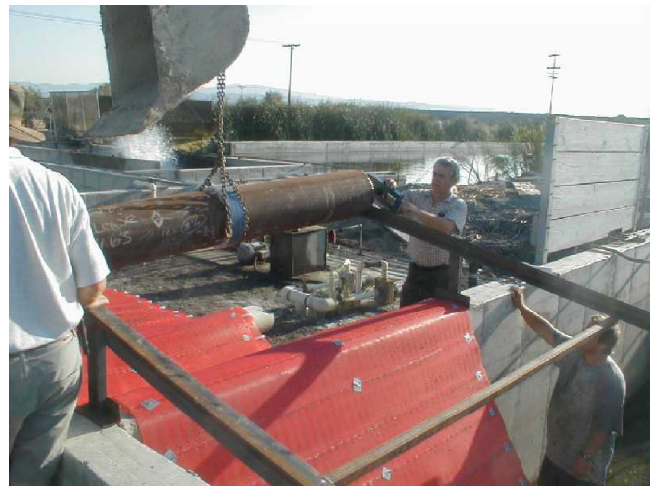
Photograph 14. Installation of the primary drive roller that supports the Algal Sedimentation Belt.

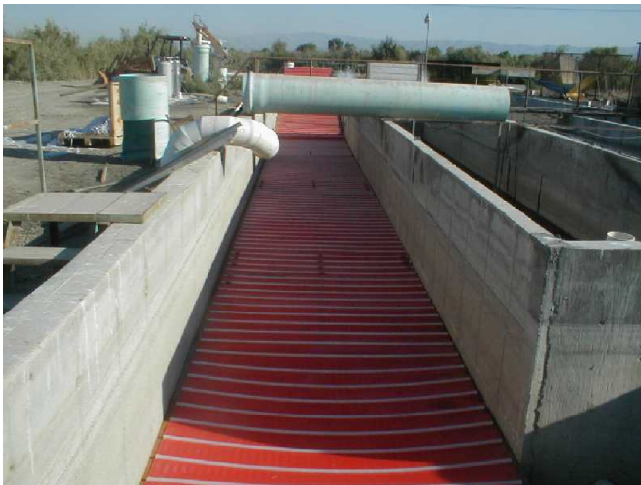
Photograph 15. The Algal Sedimentation Belt is equipped with nylon cleats that prevent the algal sludge from sliding backward as the belt exits the water surface

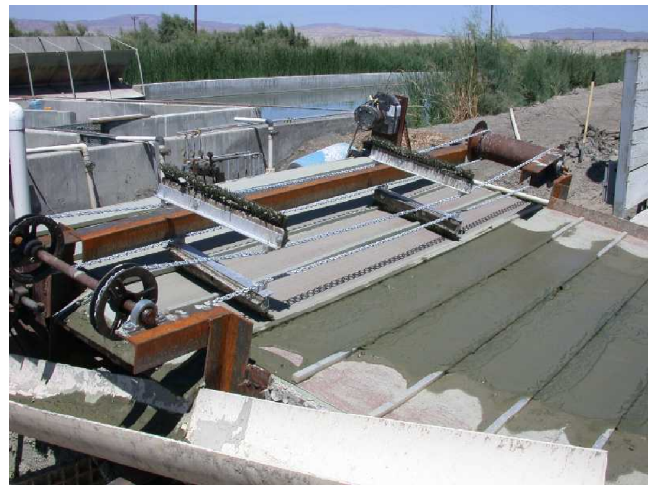
Photograph 16. A motorized cross conveyor, consisting of brushes oriented at right angles to the Algal Sedimentation Belt, work well to remove the algal sludge.

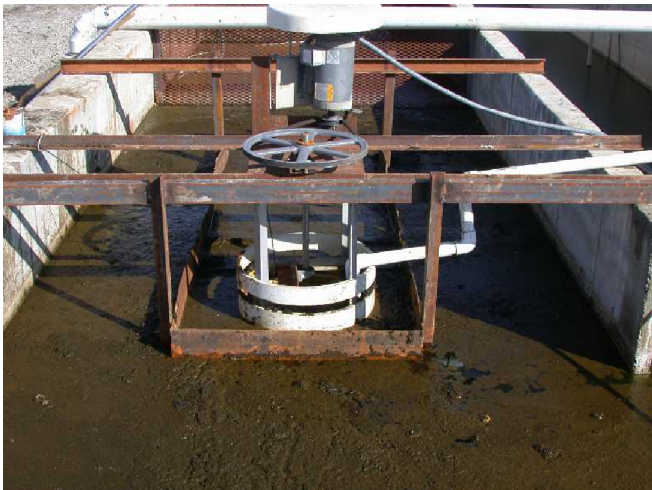
Photograph 17. A motorized flocculator was used to disperse flocculants being evaluated in the Polishing Zone.

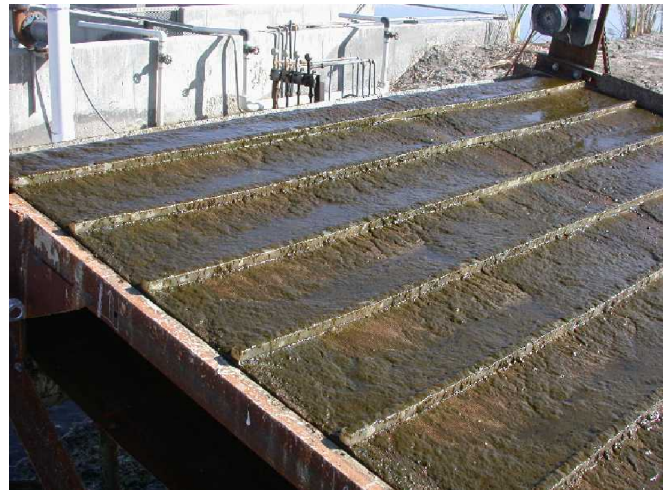
Photograph 18. Alum and ferric chloride worked well to flocculate the algae so that it could be settled and removed from the system.
